Case 252 : Narrative

Case Vehicle (A): 1999 Pontiac	Veh. (B): 1994 Ford
Type: Bonneville SE, 4-door sedan	Type: Tempo GL, 2-door sedan
Driver: 48-year-old female	Driver: 19-year-old female
CDC: 12-FDEW-1	CDC: 99-0000-0

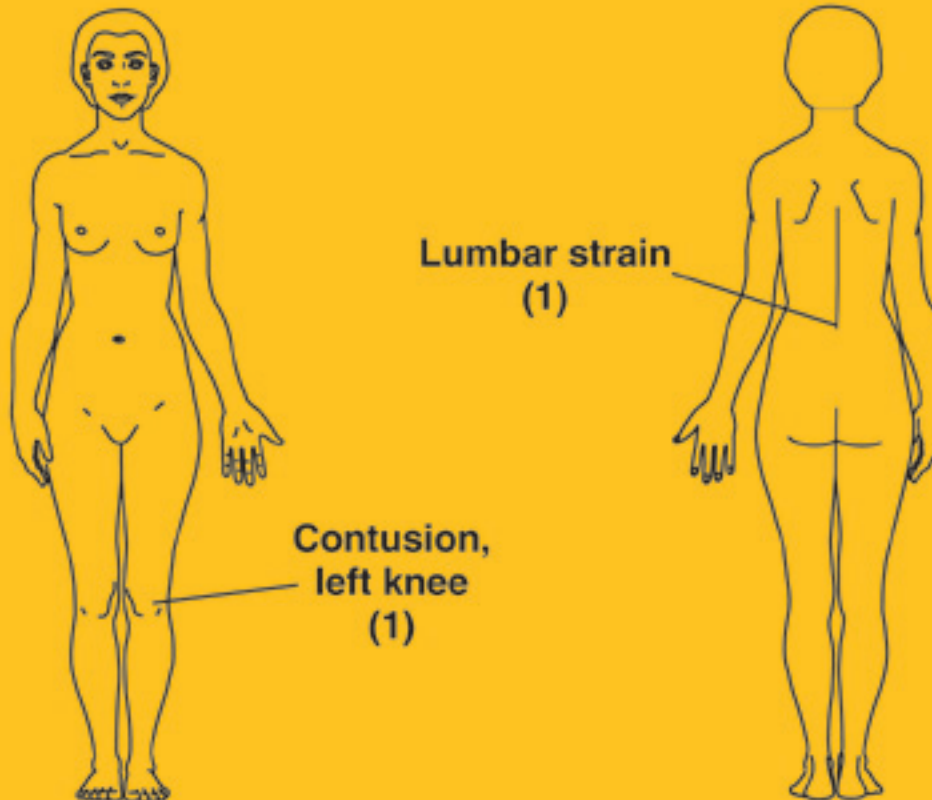
CASE NO.: 252-01

SEVERITY: MAIS - 1 : ISS - 2

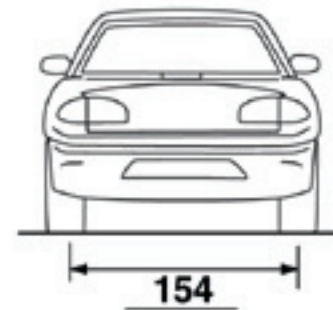
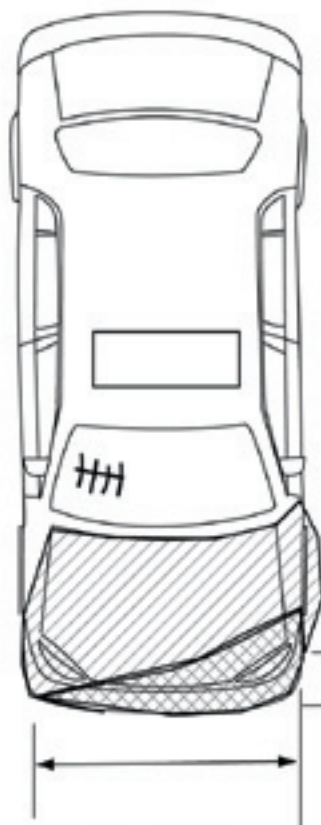
Max crush to
left front bumper
corner

25

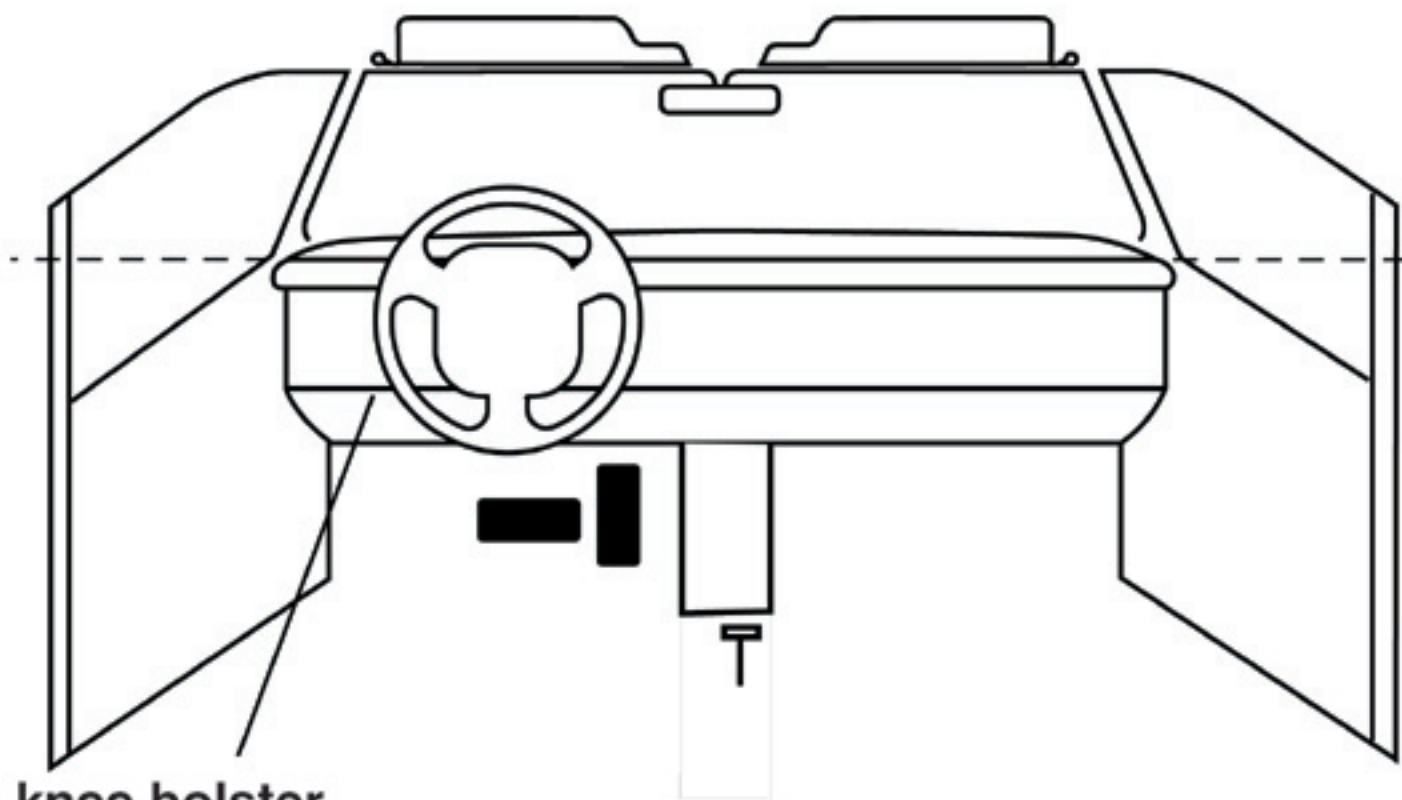
**A = knee bolster,
dent**
